DELAWARE RIVER BASIN
KAUFFMAN RUN, SCHUYLKILL COUNTY

KAUFFMAN DAM
NDS ID NO. PA-00691
DER ID NO. 54-54

PHASE I INSPECTION REPORT
NATIONAL DAM INSPECTION PROGRAM

AUGUST 1978

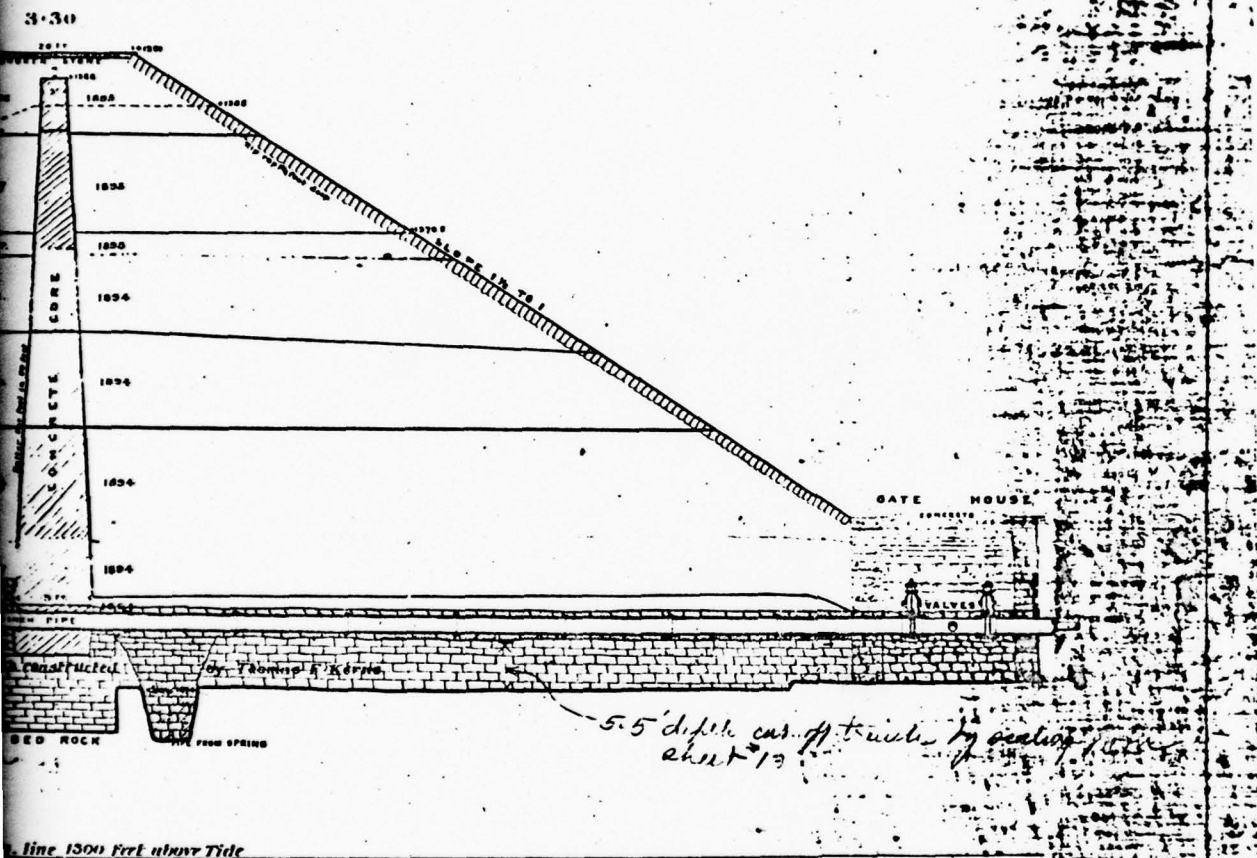
PHASE I INSPECTION REPORT
NATIONAL DAM INSPECTION PROGRAM
KAUFFMAN DAM
SCHUYLKILL COUNTY MUNICIPAL AUTHORITY
SECTION
AUGUST 1978
PLATE 3

The main features of the outlet works facilities are a masonry intake structure at the upstream slope, a 24-inch diameter CIP extending through the embankment, and a masonry valve house at the downstream toe. The masonry intake structure is located at the upstream toe of embankment. The invert at the intake structure is 1330.5. The intake structure is founded on a concrete slab. The 24-inch diameter CIP is encased in masonry. Two seepage collars, extend around the top and sides of the encasement upstream of the axis of dam. At the axis of the dam, the masonry extends down to bedrock.

The masonry valve house is located at the downstream toe of the embankment (Plate 3 and Photographs C and J). Two 24-inch gate valves within the valve house are connected in series on the 24-inch diameter CIP. A 12-inch diameter CIP with 12-inch gate valves is connected to the 24-inch diameter line between the 24-inch valves. The 24-inch line extends from the valve house about 60 feet to a concrete headwall. At the headwall, the invert elevation of the 24-inch line is 1324.0. The headwall is also the point of discharge for a 4-inch diameter drain which extends from just downstream of the core wall. The 12-inch diameter CIP is a water supply line that extends to the Owner's distribution system.

(7) Provide closure facilities for the outlet works pipe upstream of the concrete core wall for periodic inspection and for use in the event the pipe should leak severely, thereby endangering the embankment.
